**DEPARTMENT OF TRANSPORTATION**

Contract #: 04-0120F4Cty: SF/ALA Rte: 80 PM: 13.2/13.9File #: 69.28**WELDING INSPECTION REPORT****Resident Engineer:**Siegenthaler, Peter**Address:** 333 Burma Road**City:** Oakland, CA 94607**Report No:** WIR-023849**Date Inspected:** 20-May-2011**Project Name:** SAS Superstructure**OSM Arrival Time:** 700**Prime Contractor:** American Bridge/Fluor Enterprises, a JV**OSM Departure Time:** 1900**Contractor:** Zhenhua Port Machinery Corporation, Ltd (ZPMC), Changxing Island **Location:** Shanghai, China**CWI Name:** Mr. Mai Quin Li**CWI Present:** Yes No**Inspected CWI report:** Yes No N/A**Rod Oven in Use:** Yes No N/A**Electrode to specification:** Yes No N/A**Weld Procedures Followed:** Yes No N/A**Qualified Welders:** Yes No N/A**Verified Joint Fit-up:** Yes No N/A**Approved Drawings:** Yes No N/A**Approved WPS:** Yes No N/A**Delayed / Cancelled:** Yes No N/A**Bridge No:** 34-0006**Component:** Traveler Rails & Handrail**Summary of Items Observed:**

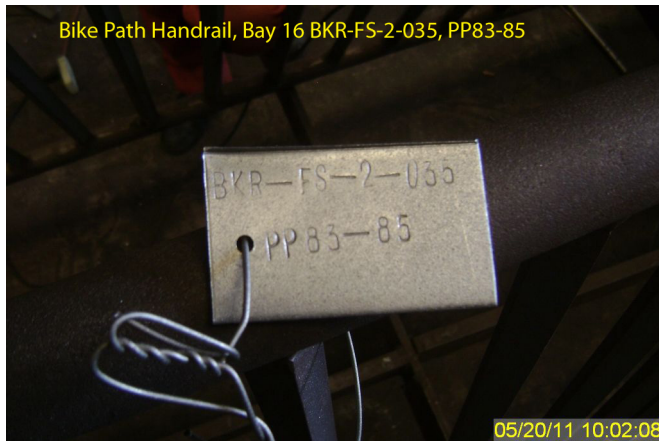
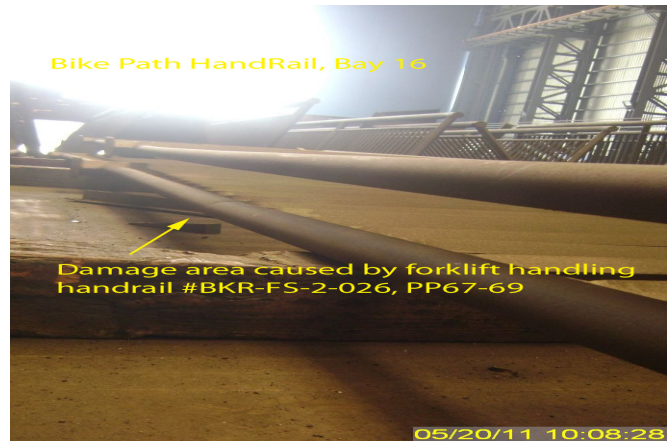
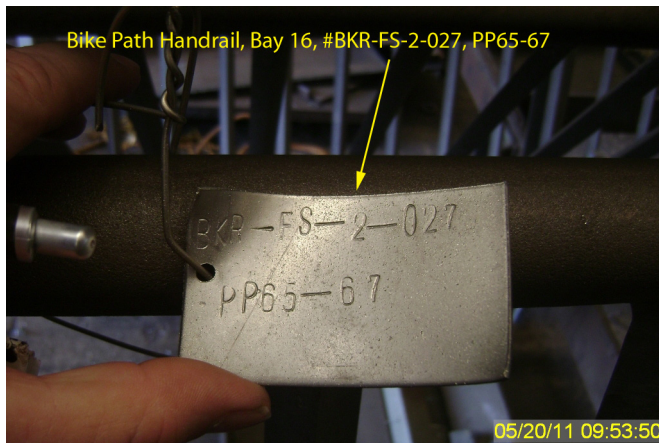
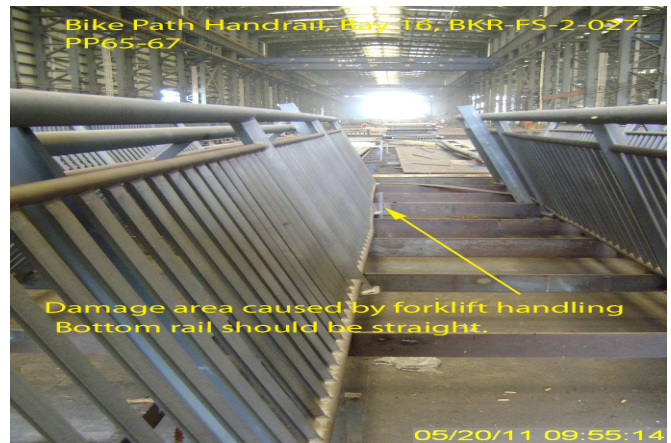
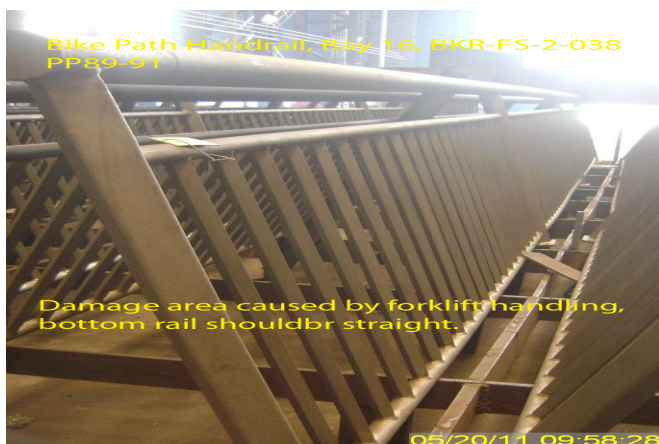
This QA noted and took photos the following components that had been returned from paint yard and was damage from poor handling of fork lift on 5-19-11, OBG, Bike Path Hand Rails. This QA informed ABF QC Liu Tao of the damage that had been cause by fork lift.

BKR-FS-2-039, PP91-93, BKR-FS-2-042, PP97-99, BKR-FS-2-027, PP65-67, BKR-FS-2-031, PP73-75, BKR-FS-2-045, PP103-105, BKR-FS-2-035, PP83-85, BKR-FS-2-037, PP87-89, BKR-FS-2-029, PP69-71, BKR-FS-2-026, PP67-69, BKR-FS-2-022, PP5-57.
